COMMISSION FOR HISTORICAL & ARCHITECTURAL PRESERVATION

STAFF REPORT

REQUEST: Demolition Hearing One – Determination of Architectural Significance

ADDRESS: 39-41 Stockton Street (Union Square Historic District)

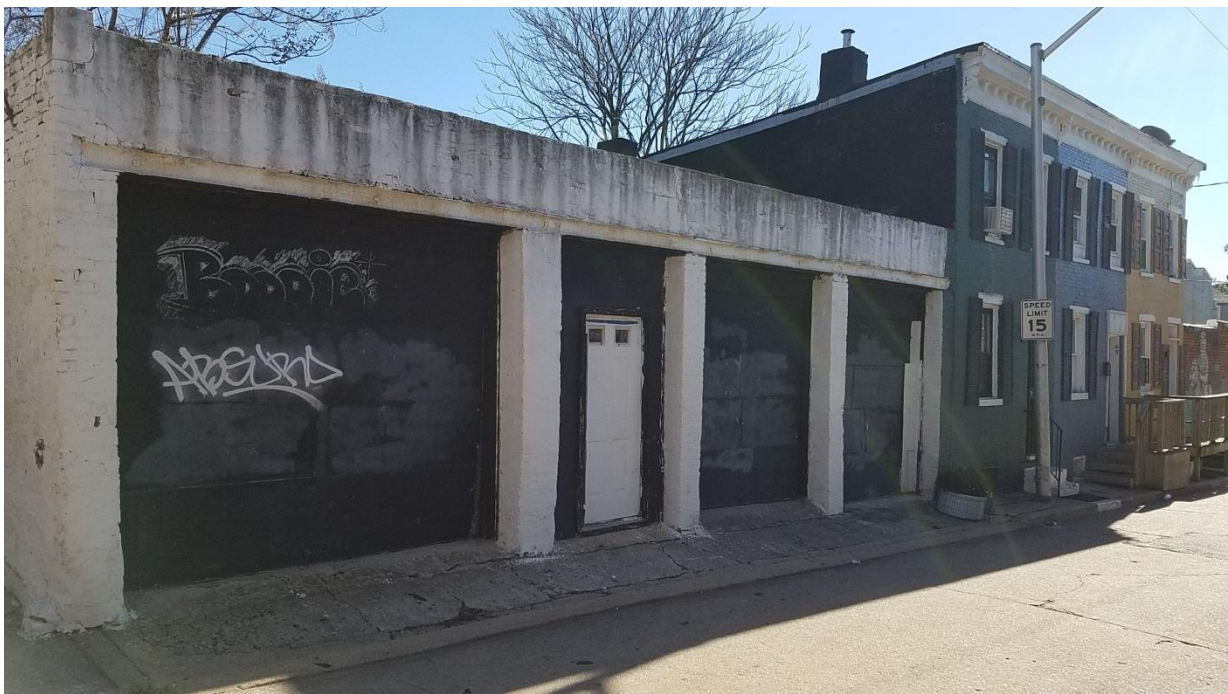
Image 4: 39-41 S. Stockton Street looking to south, January 22, 2019

This is a one-story flat-roofed painted masonry garage structure with four bays. A door has been inserted into one of the smaller bays; the other bays are enclosed. The structure abuts three two-story rowhouses to the south (*Images 4 & 5*). The building's lot is enclosed on the north and east sides by an improvised fence made of two-by-fours and sheets of plywood. The resultant enclosure attracts dumping (*Images 6-8*).

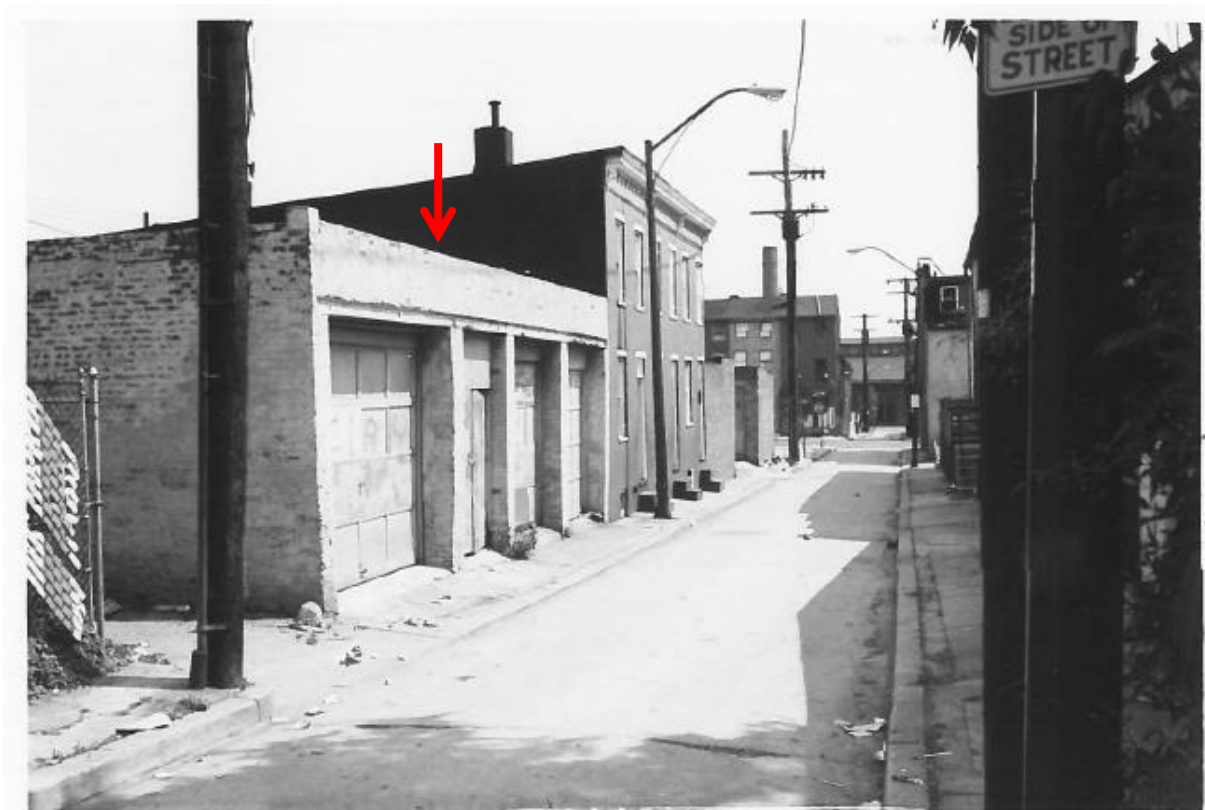
Image 12: 39-41 S. Stockton Street, Poppleton Historic Study, July 1975

The 1890 Sanborn map shows 39-41 S. Stockton Street as a two-story masonry stable with a one-story wood ell at the rear. Neighboring it to the south are five two-story rowhouses (*Image 9*). The property and its neighbors appear essentially unchanged in the 1901-1902 Sanborn map (*Image 10*). By the mid-20th century the main building is still two stories but it had gained some more additions at the rear, and it is being used for automobiles. The two southern-most rowhouses next door have been demolished and replaced by stalls or garages (*Image 11*). At some time in the early 20th century, the building was either entirely demolished and rebuilt as one story, or the second story of the original was removed. A photo from Phoebe Stanton’s 1975 *Poppleton Historic Study* shows 39-41 S. Stockton Street in its present one-story condition (*Image 12*).

39-41 S. Stockton is a simple one-story garage structure. While the original structure on the site was a two-story stable, there is no evidence of what this building looked like. What remains today is a very basic masonry building with no distinguishing architectural characteristics. The 1975 *Poppleton Historic Study* simply noted this building among the large number of garages on the interior alley streets of the block and didn't find it remarkable. The building does not meet any of the four criteria which distinguish a building in the historic district, and thus is not a contributing building.
